# Manhole Inspection Summary

Manhole # S25MM\_007MH

**Location** Address: **2427 EUTAW PL**

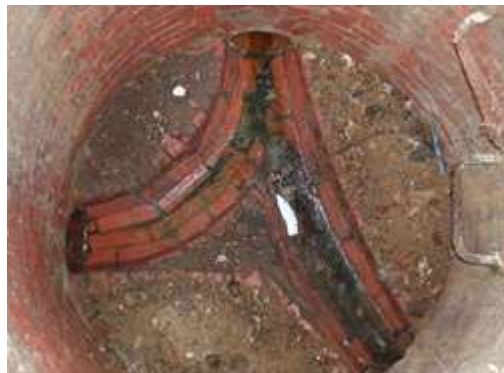
Top View

Corroded steps. Bench and Channel debris.

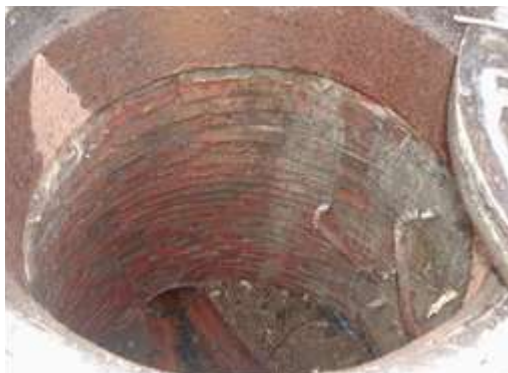
Defect

Frame leaks. Adjustment, Corbel and Barrel infiltration - other side.

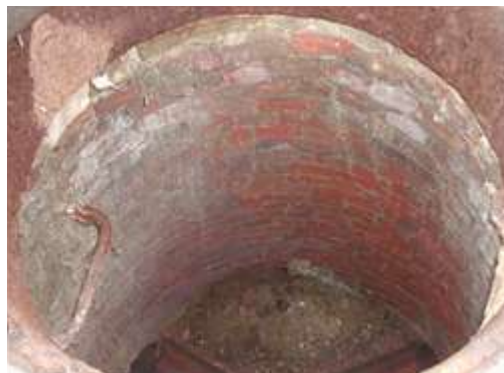
Defect

Frame leaks. Adjustment, Corbel and Barrel infiltration.

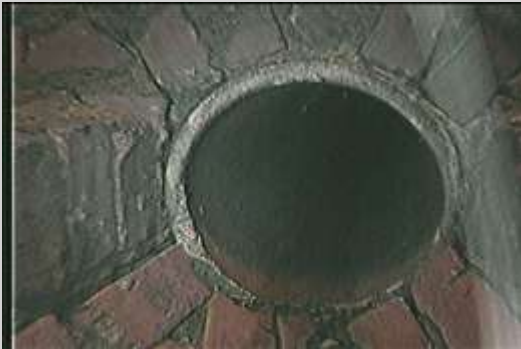
### 8 in. Circular Gravity Sewer Pipe Out @ 12 O'Clock

Infiltration: **Evidence** Pipe Seal Cond: **Cracked**

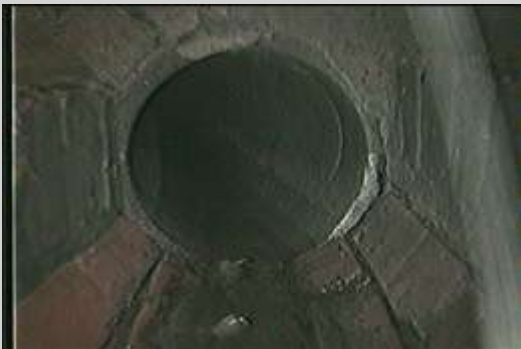
### 8 in. Circular Gravity Sewer Pipe In @ 5 O'Clock

Infiltration: **Evidence** Pipe Seal Cond: **Unknown**

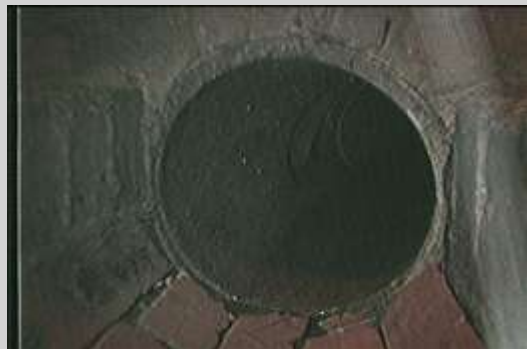
Pipe In @ 8 O'Clock

Infiltration: **Evidence**
